**PARLIAMENTARY QUALITY ASSURANCE COMMITTEE
[PQAC] REPORT**

**MEETING CRITICAL INFRASTRUCTURAL NEEDS AT THE
PARLIAMENT OF SIERRA LEONE, FREETOWN**

**THE UNITED NATIONS OFFICE FOR PROJECT SERVICES
[UNOPS]**

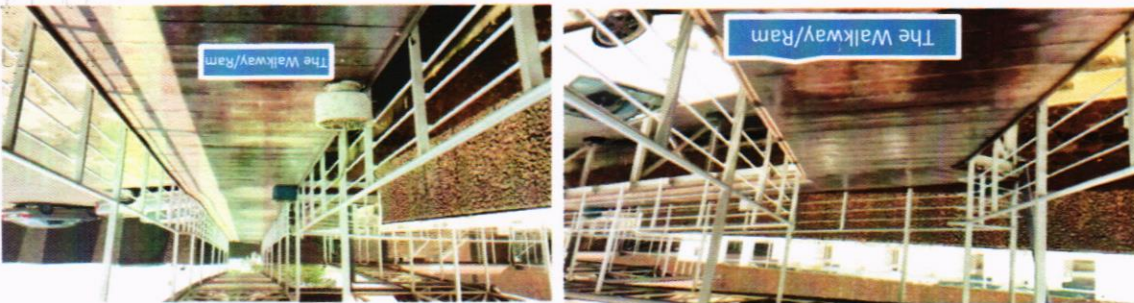
❖ the Committee also considered the walkway to be too narrow for the purpose with

no water prevention guards to prevent water from splashing on pedestrians when it rains. Consequently, the boards get slippery, making very difficult and too risky for

users. See photo below:

- ❖ the walkway facility should be temporarily put out of use until the wooden plank is replaced with concrete slab; and
- ❖ the way sides of the walkway [from the plank to the roof of both sides] are enclosed with glass or any other transparent material, thereby creating a corridor that will prevent rainwater from splashing on pedestrians whenever it rains.

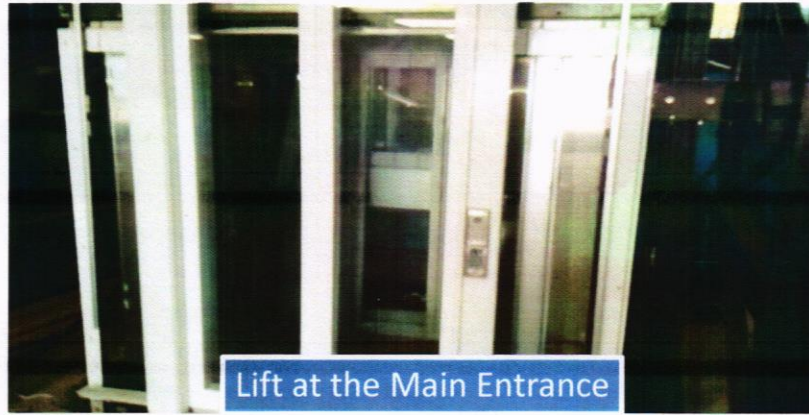
Interviews conducted and sites visited revealed that the two pits for the installation of passengers' lifts had been dug and the installation process has started. Thus, the Committee constrained to give further comments on them. As indicated in the photograph below, installation of the Main Entrance Lift is now in advanced stage. See photo below:

The site engineer informed the Committee that the Main Entrance Lift would enable people with disabilities [especially those on crutches, wheelchairs, etc.], to access important areas such as the Lower and Upper Galleries, Members' Lounge, Stall Hall and Speaker's Level within Parliament.

The Platform Passenger Lift to be installed at the Committee Level Floor would enable same to access the famous Committee Room 1 where Presidential Nominees are vetted and Bills are scrutinised. The Committee observed that the installation process has commenced.

- ❖ UNOPS expedites the completion of the installation process, so that the facility is made available to would-be users and proper repairs and maintenance plans (including trainings) are shared with Parliament's Facility Teams;
- ❖ The newly established PTC to follow-up on the quality of works and the quality of materials in use; and
- ❖ Any future opportunity of same, the area to consider first should be at the back of the Main Building, where there are more staircases.

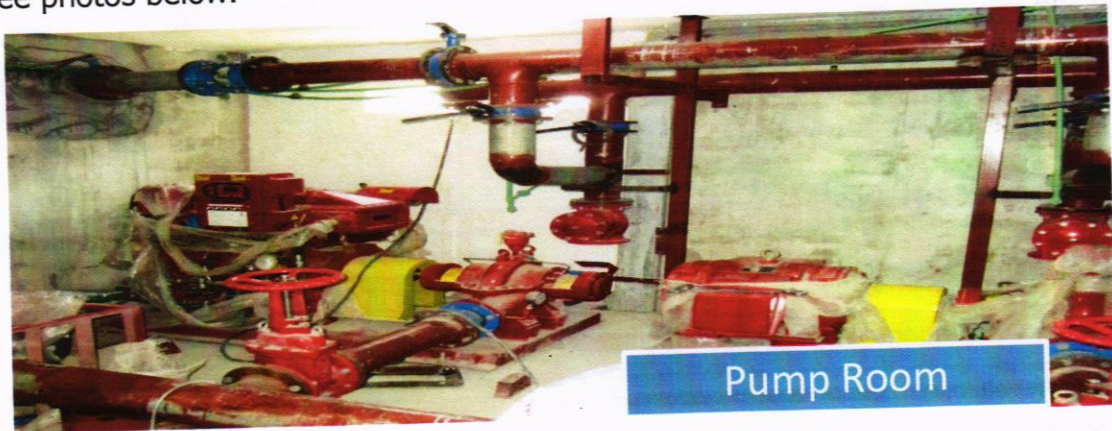
- ❖ work has resumed at the Pump Room Station and sixty to seventy percent of installation of pipes and other equipment had been done, after several months of stalemate due to termination of initial contract as a result of underperformance and other challenges encountered with the contractor;

See photos below.

- ❖ **UNOPS fast-track the completion of the installation of pipes and other equipment, so that the facility is made available to end users;**

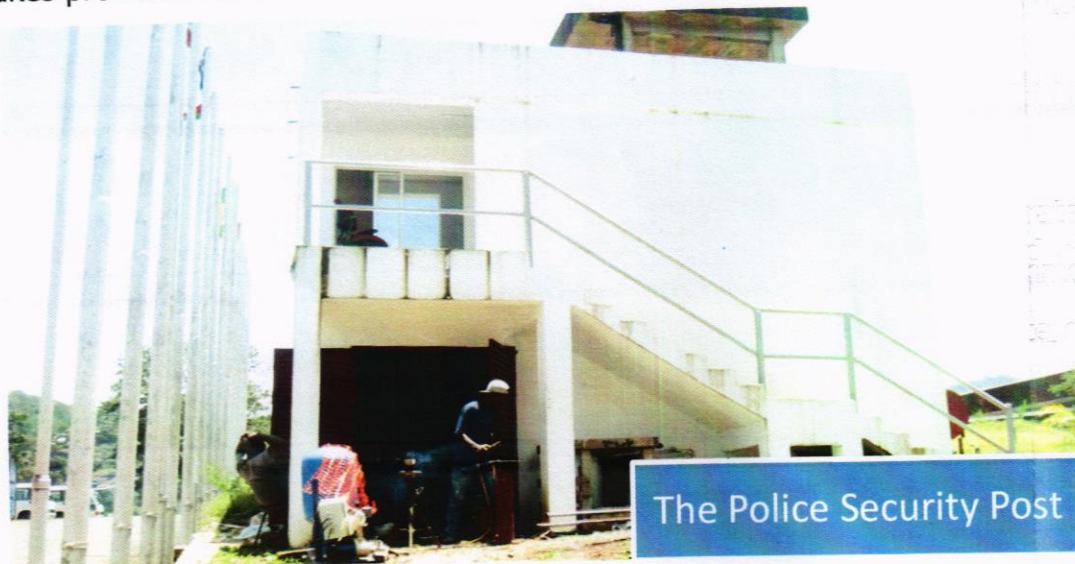
A Police Post, which was not part of the Project, was also incorporated and eventually constructed at the top of the Pump Room to address the accommodation problem the police officers are currently facing, so as to provide adequate security within the precincts of Parliament. The new security structure, as shown below, makes provision for an office, two toilets and a lobby.

While applauding the Project Board for suggesting the construction of a Police Post, the Committee recommends that proper care is taken.

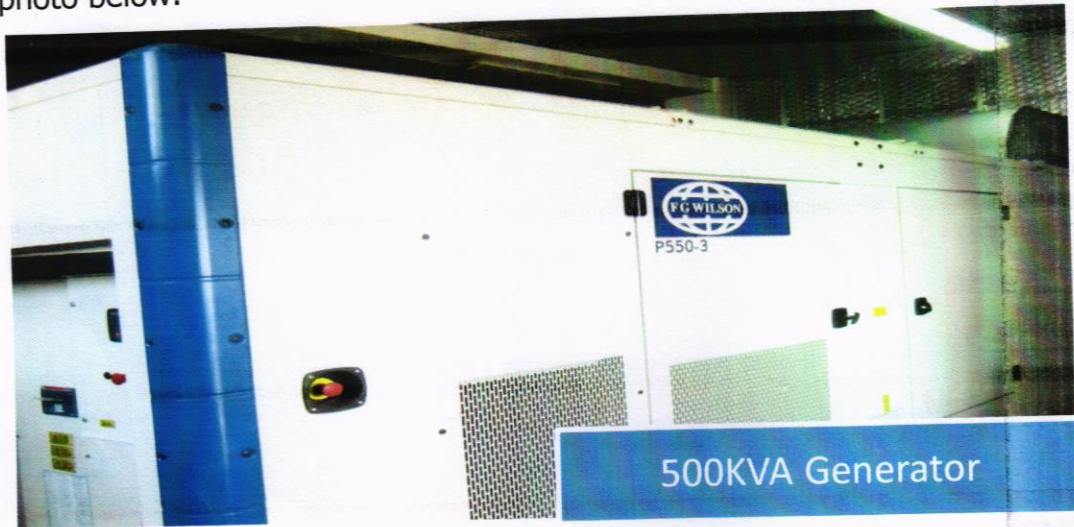
- ❖ the procurement and installation of 500KVA Generator was awarded to IPC Company and the said generator was rated **99%** satisfactory by Engineers from Electricity Distribution and Supply Authority [EDSA] and Electricity Generation and Transmission Company [EGTC] from the Ministry of Energy [MoE]. However, the Engineers expressed concern over the limited space in which the generator is installed, stating that it is not well-ventilated. When this concern was brought to the attention of Ing. Trudy Morgan, she promised to look into the issue and probably suggest ways of addressing same;

See photo below:

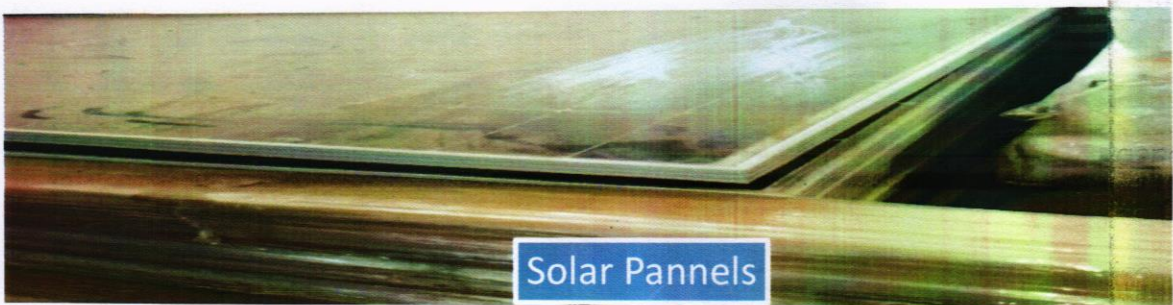
- ❖ Apart from the current electricity consumption rate in Parliament, the said generator is believed to provide electricity for more than ten additional buildings with similar electrical load, even though it was rumored that its consumption rate is twice higher than the previous generator;
- ❖ The Stanchions and other materials for the installation of Solar Panels and Inverters have been procured and work has commenced at the Forecourt. See photos below:

It was revealed that when completed, the Solar PV would help to reduce the electricity problem in the event there is no electricity supply from EDSA or the generator.

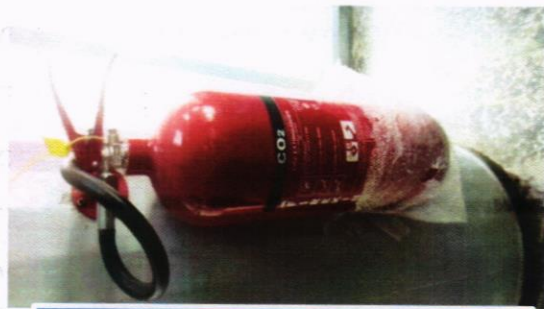
Fire Extinguisher

Firefighting system is a very important activity geared towards preventing fire from causing more damage and institutions are taking proactive steps to ensure that modalities are put in place to tackle this menace. The Committee noted during sites visits and interviews conducted that the firefighting equipment [such as hydrants and extinguishers], as shown in the photo below, have been procured and distributed to strategic locations within the Building.

While noting the final phase of the installation process is now in advanced stage, the Committee however recommends that additional hydrants and extinguishers are provided and proper training is given to staff on how to use them.

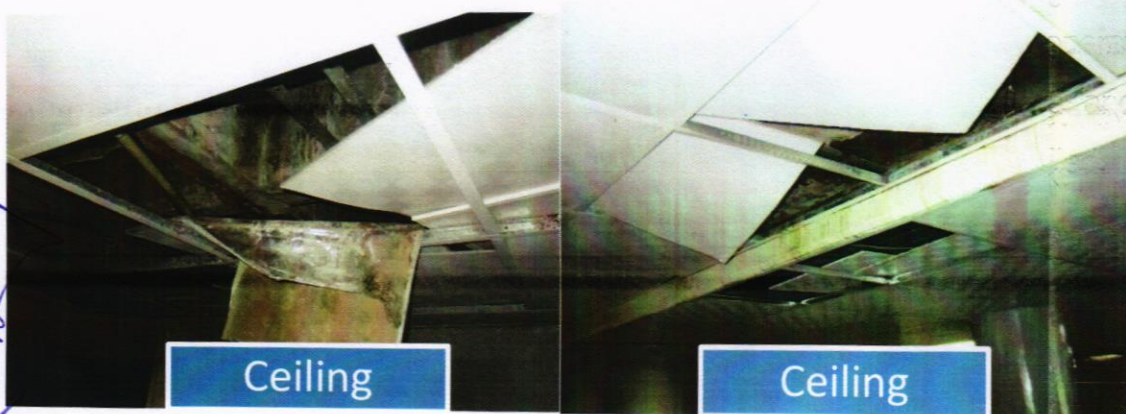
- ❖ The work for the installation of ceiling tiles was not properly done and in some areas within the Building, the ceiling tiles have started falling down as shown below. It was also observed that the ceiling tiles in some areas were removed by the contractors, so as to prevent them from being affected by the leakage. The Committee however noted that the contract to address this issue had been awarded and work has commenced;

In view of the above and in consideration of the fact that these aspects of the Project are still under construction, the Committee recommends that the PTC follow up with the ongoing works with a clear focus on the quality of workmanship and materials.

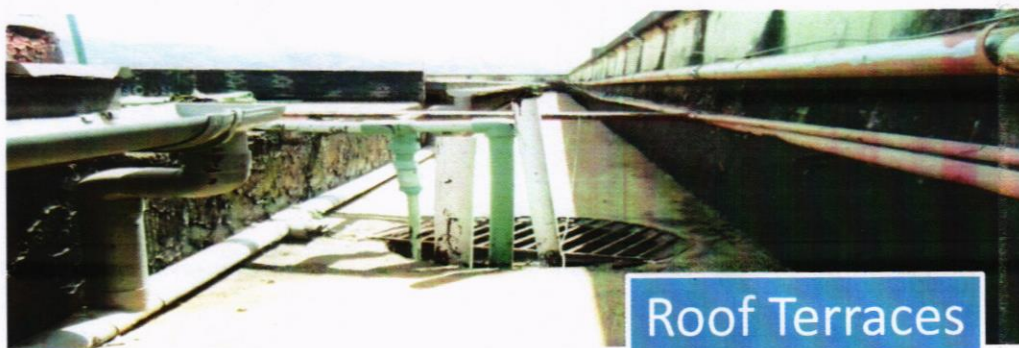
- ❖ As shown in the photo below, the pipes that were installed in the drainage gutters [pass through the male and female public toilets situated along the Speaker's Level] were poorly installed and this caused serious leakages in those toilets and other places;

Based on the foregoing and in view of the fact that work is ongoing and it is very difficult to determine, at this period, whether the leakages have been addressed or not, the Committee recommends that the PTC follow up on the ongoing works with a view to ensuring that all defects associated with the leakages are adjusted and the Project Board should ensure that the broken window glasses in the Library, State Hall and other offices are replaced without further delay. The PTC should also investigate properly and report on the causes of the cracks.

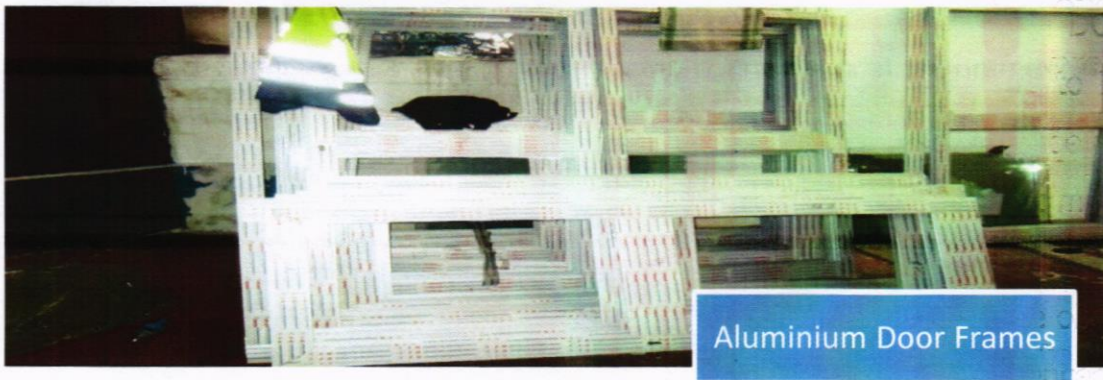
(xi) MAINTENANCE OF THREE [3] MAIN ENTRANCE AND SIXTEEN [16] EXIT DOORS
 The contract for the installation of three main entrance doors was awarded to BDEV. The Committee first realised that the three main entrances were supposed to be access control (biometric) doors and fire rated, but the ones initially installed did not meet the requirements. It was also noted that the sixteen [16] exit doors that were installed are substandard and most of them were malfunctioning. However, the Committee observed that the contract to replace same had been awarded and work has commenced. See photo below:

In this regard, the Committee recommends that UNOPS exercises urgency and ensures that the work is expedited and the PTC follow up on the ongoing works with a view to confirming the quality of glass and quality workmanship.
