**PARLIAMENTARY QUALITY ASSURANCE COMMITTEE
[PQAC] REPORT**

**MEETING CRITICAL INFRASTRUCTURAL NEEDS AT THE
PARLIAMENT OF SIERRA LEONE, FREETOWN**

A PROJECT FUNDED BY THE EUROPEAN UNION [EU]

**THE UNITED NATIONS OFFICE FOR PROJECT SERVICES
[UNOPS]**

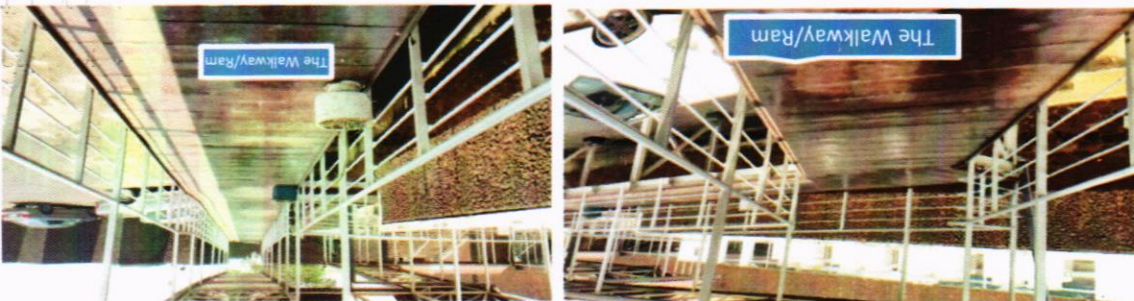
❖ the Committee also considered the walkway to be too narrow for the purpose with

no water prevention guards to prevent water from splashing on pedestrians when it rains. Consequently, the boards get slippery, making very difficult and too risky for

users. See photo below:

- ❖ the walkway facility should be temporarily put out of use until the wooden plank is replaced with concrete slab; and
- ❖ the way sides of the walkway [from the plank to the roof of both sides] are enclosed with glass or any other transparent material, thereby creating a corridor that will prevent rainwater from splashing on pedestrians whenever it rains.
